The Effects Of Stress Mitigation On Nondestructive Examination

**Prepared for the
U.S. Department of Energy
Assistant Secretary for Environmental Management
Under DOE Idaho Operations Office
Contract DE-AC07-99ID13727**

INEEL/EXT-04-02199

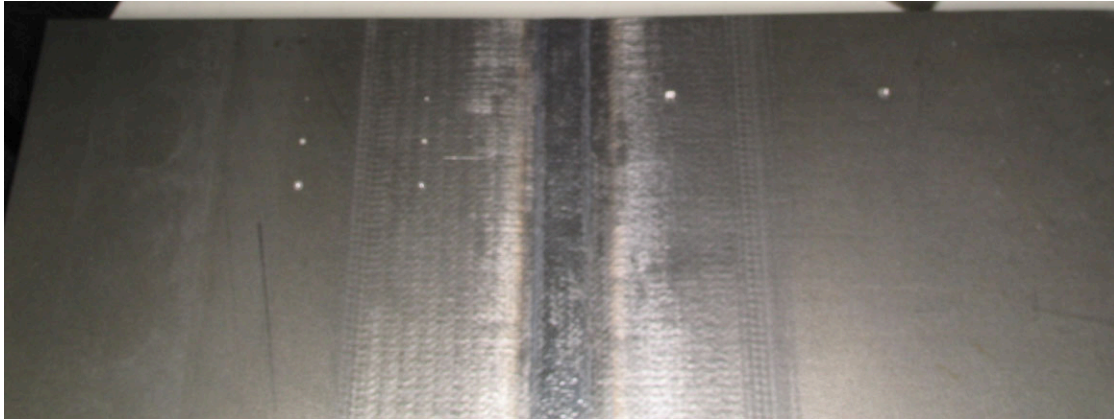
Figure 1. Laser peening sample block. The laser peened section is the 4.4-in.-wide textured area centered over the weld. The remaining areas are in the as-received condition. Simulated pit targets are visible on the left side. Notches used for the ultrasonic measurements are located on the bottom side of the block under the right side surface in this image. Topside notches of the same size are visible on the right side.

A test block for each stress mitigation technique was obtained for evaluation. One block was stress mitigated with a laser peening (LP) method. This block, provided by Lawrence Livermore National Laboratory (LLNL), had a portion of its surface (including the weld) treated by the LP mitigation method and a portion left in the as-received un-stress-mitigated condition. Figure 1 shows a photograph of the top surface of the LP block. The block is nominally 1 in. thick with no marked difference in the thickness between the stress-mitigated and un-stress-mitigated sections. The stress-mitigated section extended about 2 in. from the weld reinforcement on the block. A significant area was left without stress mitigation. The block had large bracing structure attached to the bottom of the block presumably to support the block during welding. A metal channel was welded to the bottom side over the weld joint location. The purpose of this channel is unknown.

It was observed that the LP process was a raster process, with the primary direction of the raster parallel to the weld bead (that is, the laser spot was moved in a line down the weld, then shifted horizontally and the line repeated). This resulted in obvious shallow “grooves” parallel to the weld in this block. In the actual process, on a waste package the primary raster direction will be transverse to the weld to avoid making many circumferential passes over the package. During the actual processing, the primary inspection with ultrasonic test equipment will direct the ultrasonic signal in a direction transverse to the weld. The experiments performed for this report have an orientation with respect to the grooves that corresponds to the proper orientation of the LP raster to the weld bead in the actual waste package. The ultrasound probe in the experiments described in this report is directed at the targets in the LP block such that the horizontal component of the sound path was in the same direction as the raster, to be consistent with the relative direction on the actual waste package. This configuration of the block allowed the experiment to be performed over larger angles of incidence.

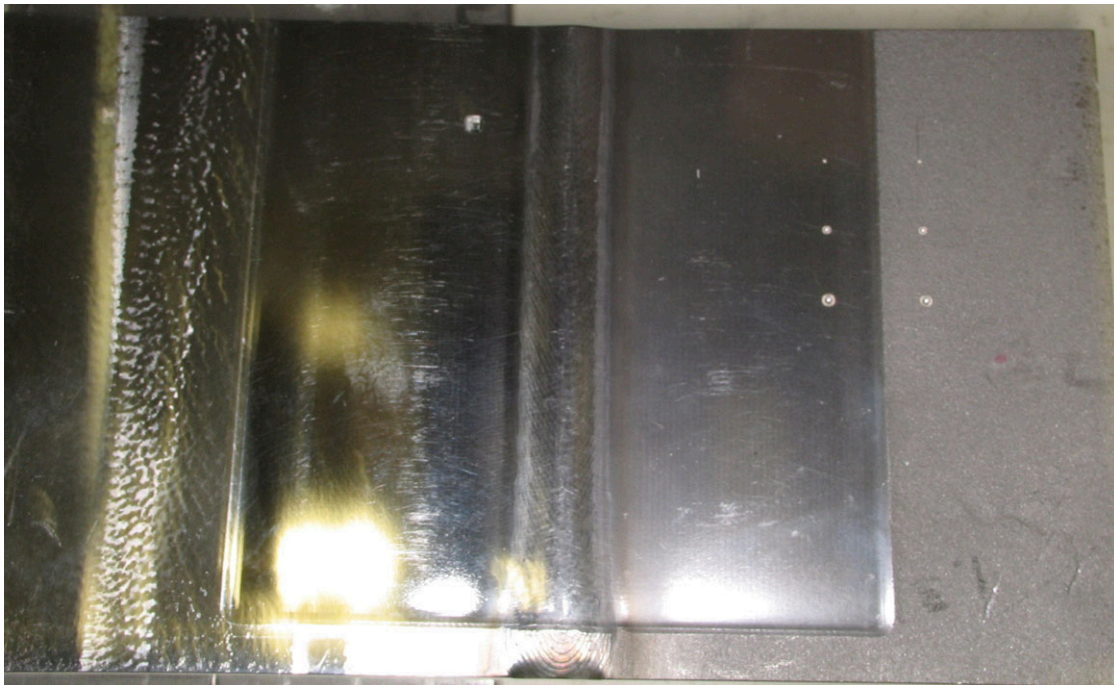
Figure 2. Controlled plasticity burnishing sample block. The stress-mitigated area is the smooth 4.25-in.-wide area centered over the weld. The area on the left has been faced with a cutting tool, while the area on the right is in the as-received condition. Simulated pit targets are visible on the right side. Notches used for the ultrasonic measurements are located on the bottom side of the block under the left side surface in

this image. Top side notches of the same size are visible on the right side of the image. An abrupt transition from the stress-mitigate area to the base material is visible in the photograph.

plasticity burnishing (PB). BSC provided INEEL the material for the block. One side of the block is 1.31 in. thick; the other side is 1.5 in. thick. PB stress mitigation was performed over the weld crown and about 2 in. to each side of the weld crown. Portions of the block outside the stress-mitigated area were left unchanged. Figure 2 shows a photograph of the top surface of the PB block. There is no apparent direction to a surface texture on the PB stress-mitigated area. The surface, as is apparent in Figure 2, is very smooth. An abrupt elevation change occurs at the edges of the stress-mitigated area, which is about 0.04 in. lower than the base material surface.

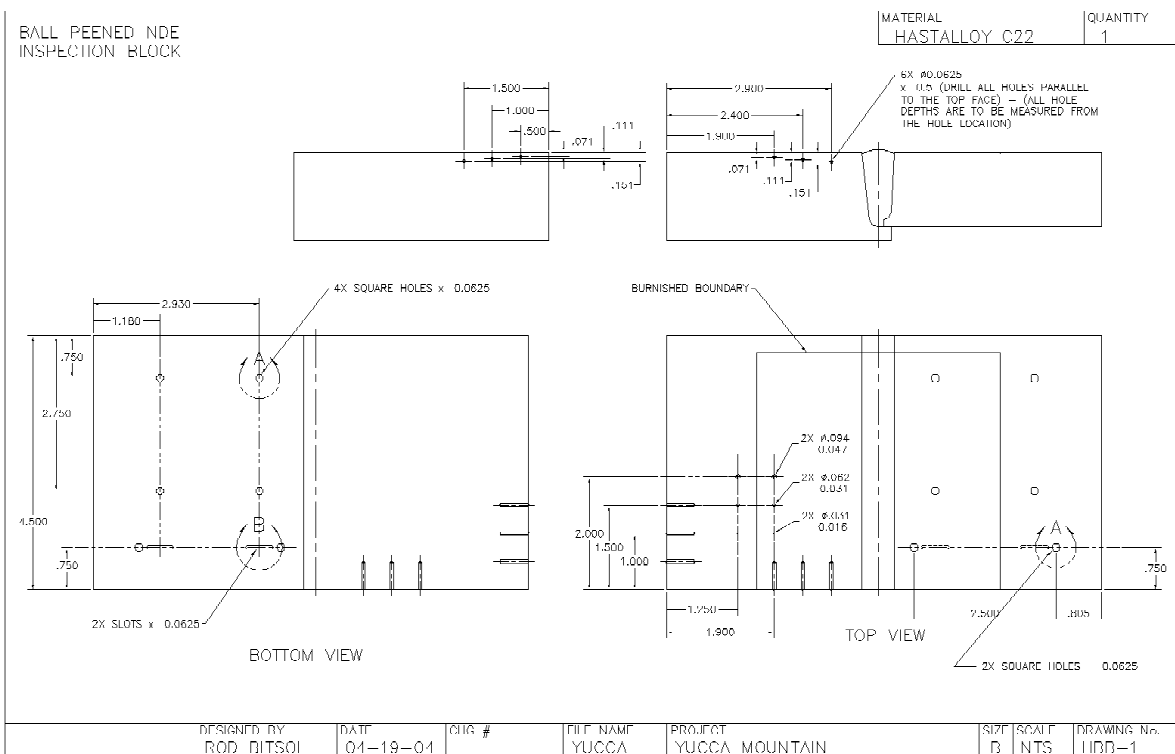
Figure 3. Drawing of the target locations in the controlled plasticity burnishing sample block. Targets include simulated pits, notches, and side drill holes, identical flaws that are in both the base material and stress-mitigated areas.

Two different types of simulated flaws were used to evaluate the eddy current responses. The first was a series of simulated pits machined into the surface of the two mitigation samples using ball endmills. The series consisted of three pits that bracketed the 0.063-in.-minimum flaw size (see Table 1). Identical sets of pits were placed in unmitigated and mitigated sections in both test blocks. As with the ultrasonic inspection, this approach permits direct comparison of the eddy current responses for each surface condition in a single test block without the material differences that may result from heat-to-heat variations. The second was an identical set of 0.063-in.-diameter side-drilled holes varying in depth from the top surface (see Table 2). The objective of machining these holes was to evaluate the effects of mitigation on the ability to detect near-surface defects. Figures 3 and 4 show the locations of these

features. The targets in the base material act as reference targets to establish the system's baseline response. Responses from identical targets located in the mitigated regions can then be compared to the baseline responses to determine relative changes in the recorded signals due to stress mitigation.

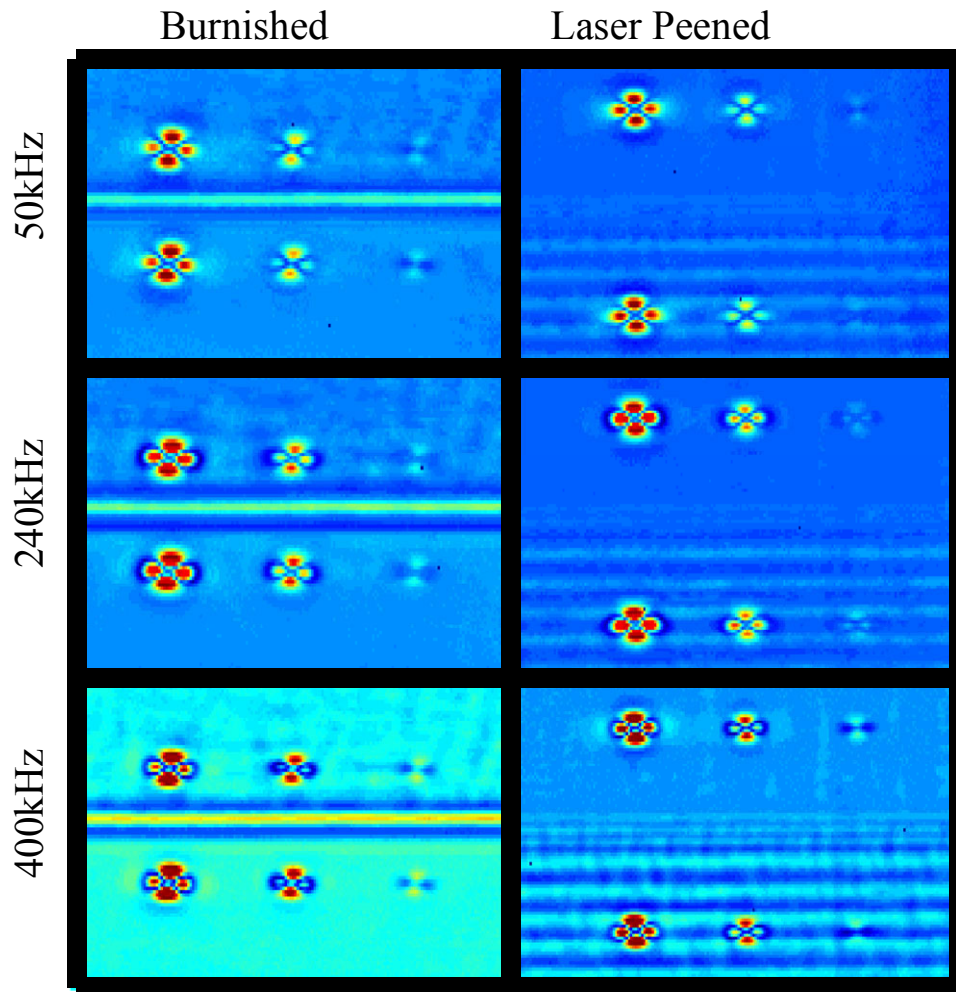
Figure 6. Eddy current raster scans of stress mitigation test blocks.

Raster scans were performed at three test frequencies: 400, 240, and 50 kHz. A number of frequencies were used to vary eddy current skin depth (depth at which the amplitude of the eddy currents drop to 1/e of its value at the surface). Assuming constant electrical conductivity and magnetic permeability, skin depth will increase as test frequencies are lowered. Increasing the skin depth will distribute more of the eddy currents deeper into the test material, thereby reducing sensitivity to surface/near surface variations and geometry. Unfortunately, this also reduces sensitivity to surface defects, yet often a test frequency can be found that will minimize unwanted surface condition responses while still having adequate sensitivity to defects. Figure 6 presents a collection of the images obtained for the two different mitigation test blocks. The images in the figure all have mitigated regions on their lower half and pit sizes running left to right, ranging from largest to smallest. Appendix B presents detailed

images and test parameters. These high-resolution scans were produced using data collection steps of 0.010 in. (0.25 mm) with raster steps of 0.20 in. (5.0 mm). The vertical and horizontal line traces provided with the images center on the 0.063-in. pit in the mitigated region of the test blocks.

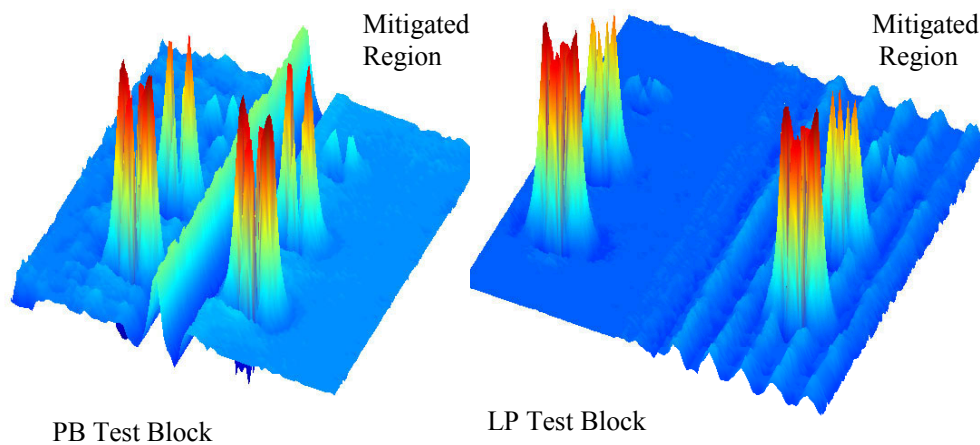
Figure 8. Surface plots of the raster scans collected at 240 kHz for the two mitigation test blocks. Equivalent instrument settings were used for both scans.

The basic trends observed are that, when compared to the unmitigated surfaces, the BP process increases the signal-to-noise ratio while the LP process decreases the ratio. Figure 8 illustrates that both processes produce a distinct shift in the electrical conductivity of the surfaces mitigated, i.e., the base response shifts up (decrease in conductivity) in the mitigated regions. However, due to the uniformity of the PB process and resulting smooth surface finish, material noise is reduced, but in the LP region the coarse raster steps and resulting surface roughness produce significant local variations. This imparts significant material noise into the eddy current signal for the LP process.

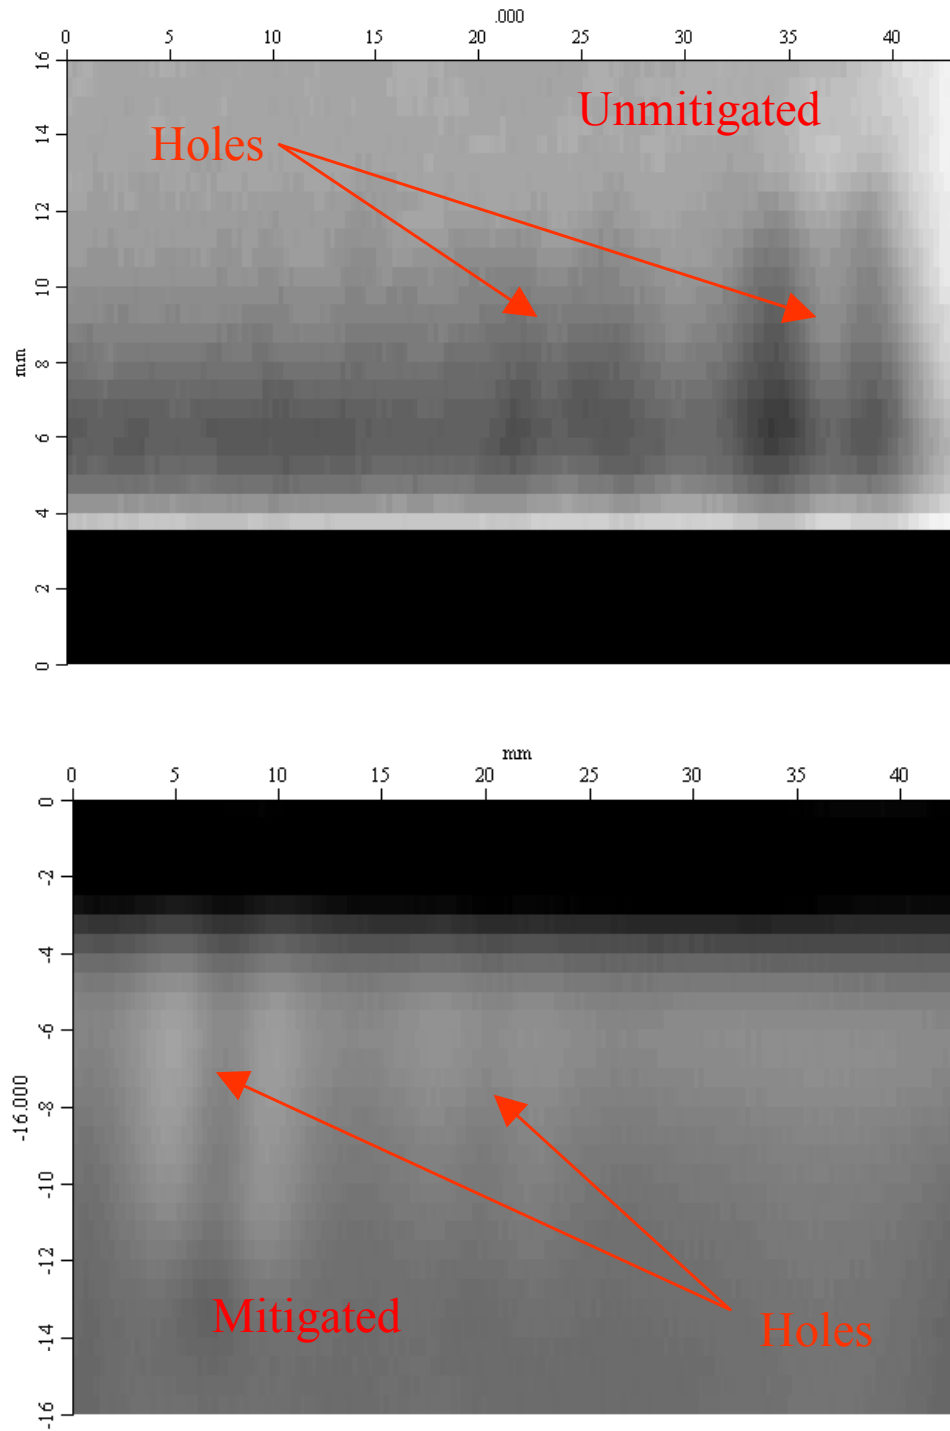
Figure 9. Raster scans over the side-drilled holes in the low plasticity burnished test block. Only the two side-drilled holes nearest to the top surface can be detected.

Raster scans were performed over the location of the side-drilled holes at 50 kHz, the lowest recommended test frequency for the 3479-1-A Probe. A 50-kHz test frequency yields a skin depth of about 0.094 in. (2.4 mm) in alloy 22. As a result, sensitivity to the deeper holes will be significantly reduced compared to the hole located 0.063 in. below the surface. Figures 9 and 10 show images from the raster scans. The scans start at the very edge of the blocks and move inward. Edge effects mask any results until the probe is 0.158 in. (4 mm) from the edge. Scans were performed with data collection steps of 0.010 in. (0.25 mm) and raster steps of 0.020 in. (0.5 mm). Also note, for the PB block, scanning was performed in two directions. This results in opposite coils sensing the holes, thereby producing a 180-degree shift in the defect response seen between the unmitigated and mitigated sections of the test block. The images indicate that only the two side-drilled holes nearest to the top surface can be detected, and the second deepest hole (0.80 in./2.0 mm from the surface) detected only marginally.

The reduced signal-to-noise ratios for the unmitigated region of the PB block and the mitigated region of the LP block further diminish the responses, thereby making detection even less reliable.

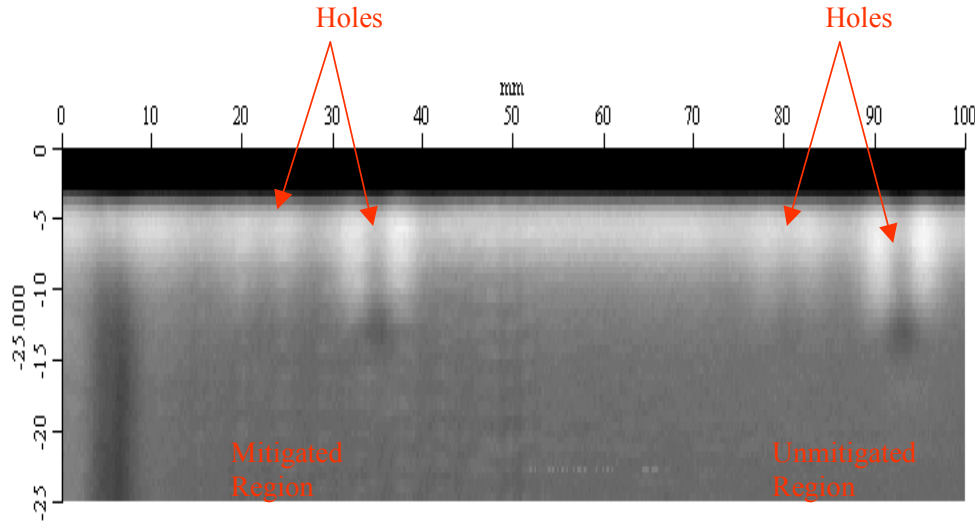
Figure 10. Raster scan over the side-drilled holes in the LP block. Only the two side-drilled holes nearest to the top surface can be detected.

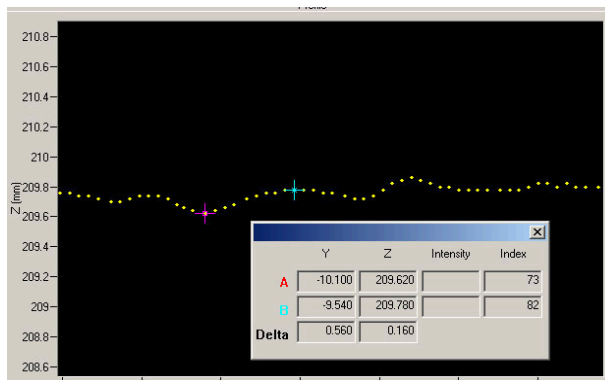
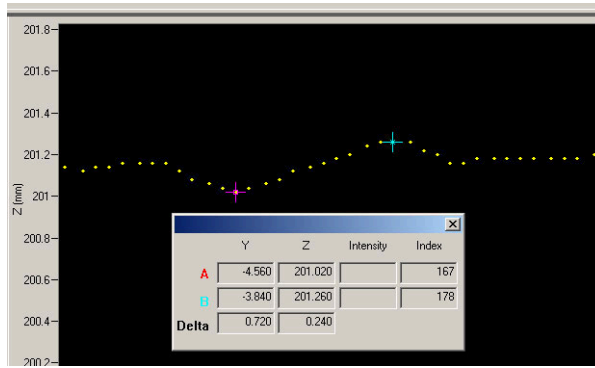
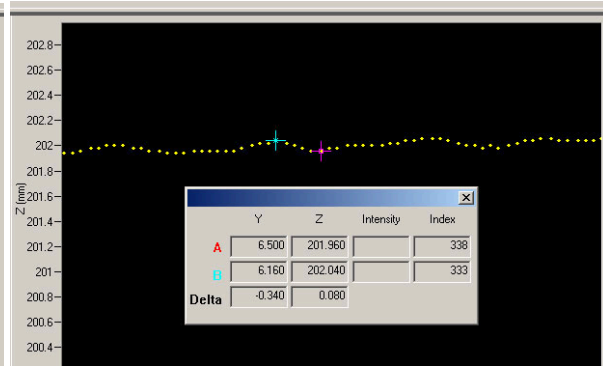
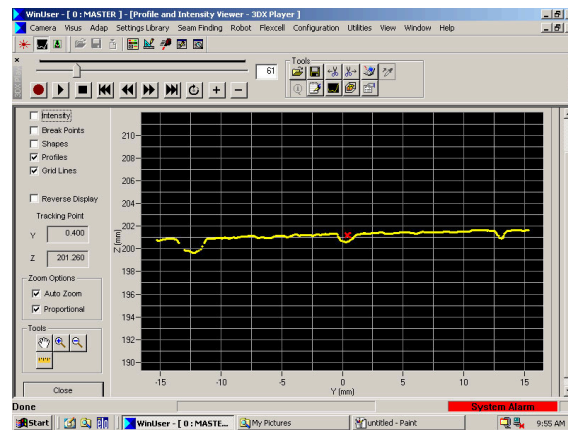
(a) Stress-mitigated PB sample block.

(b) Base material PB sample block.

(c) Stress-mitigated LP sample block.

(d) Base material LP sample block.

(e) Stress-mitigated LP block with reference pits (worst case).

Figure 11. Profile measured across a typical profile of each section of the blocks and the worst case LP with the reference pits. The maximum surface variations from adjacent peaks and valleys were 0.16 mm (0.006 in.) on the PB block and 0.24 mm (0.009 in.) on the LP block. The maximum surface variation on the base material was 0.10 mm (0.004 in.). Profiles of the reference pits are shown for the LP stress-mitigated surface.

Typical profiles across stress mitigated and base material areas of each block are shown in Figure 11. The elevation change from adjacent peaks and valleys in the surface contour is considered the appropriate measurement. The elevation change in the LP block is typically larger than the PB block. This is apparent even in the photographs in Figures 1 and 2. A typical variation for the LP block is 0.009 in.; a typical variation in the PB block is 0.006 in., as shown in Figure 11. Compared to the smallest reference pit (0.0157 in. deep), both surfaces as measured by the visual sensor would have a significant percentage of error in depth measurement. For the detection requirement of 0.063 in., the error in measurement of depth of a contour in the LP texture could be as high as +14% if a local peak in the texture were measured as part of a surface pore. The error in measurement of the depth in the PB plate would be 10%. The base material measures as much as a 0.04-in. variation, giving a 6% variation. There is a measurable difference in the effect of the two types of stress mitigation methods for the visual inspection system. The sizing of flaws is diminished by 0.009 in. However, it is clear from the worst-case stress mitigated LP block, shown in Figure 11e, there is no apparent issue with detecting a pit even one-half the critical flaw size.

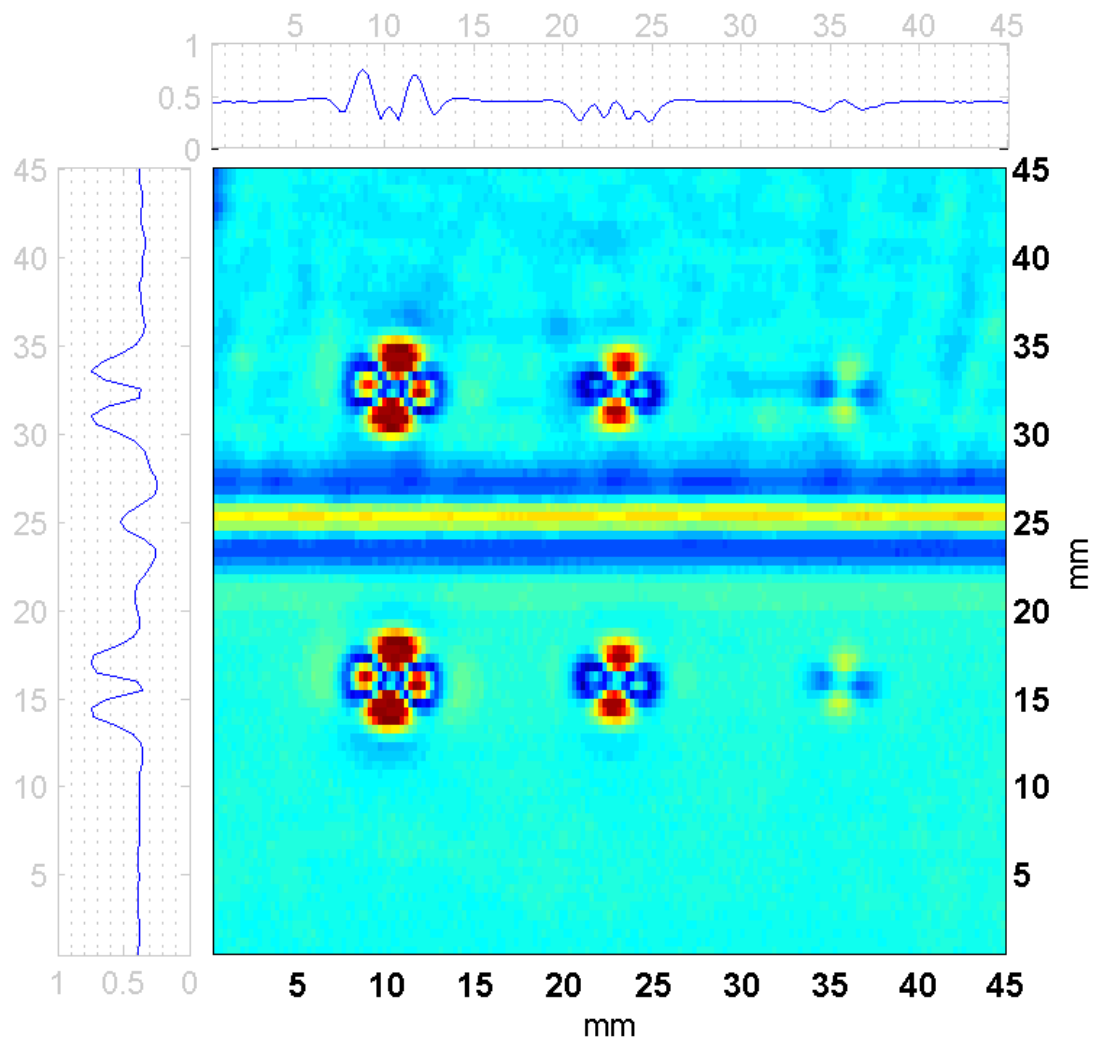
Figure B-1.

Sample:	PB Block
Mitigated Region:	Lower half
Instrument:	ZETEC MIZ 22
Probe:	ZETEC 3479-1-A Plus Point (run in differential mode)
Scan Size:	45 mm × 45 mm
X Step Size:	0.25 mm
Y Step Size:	0.50 mm
Test Frequency:	400 kHz
Gain	26 dB
V/H:	8/8
Phase:	25 degrees

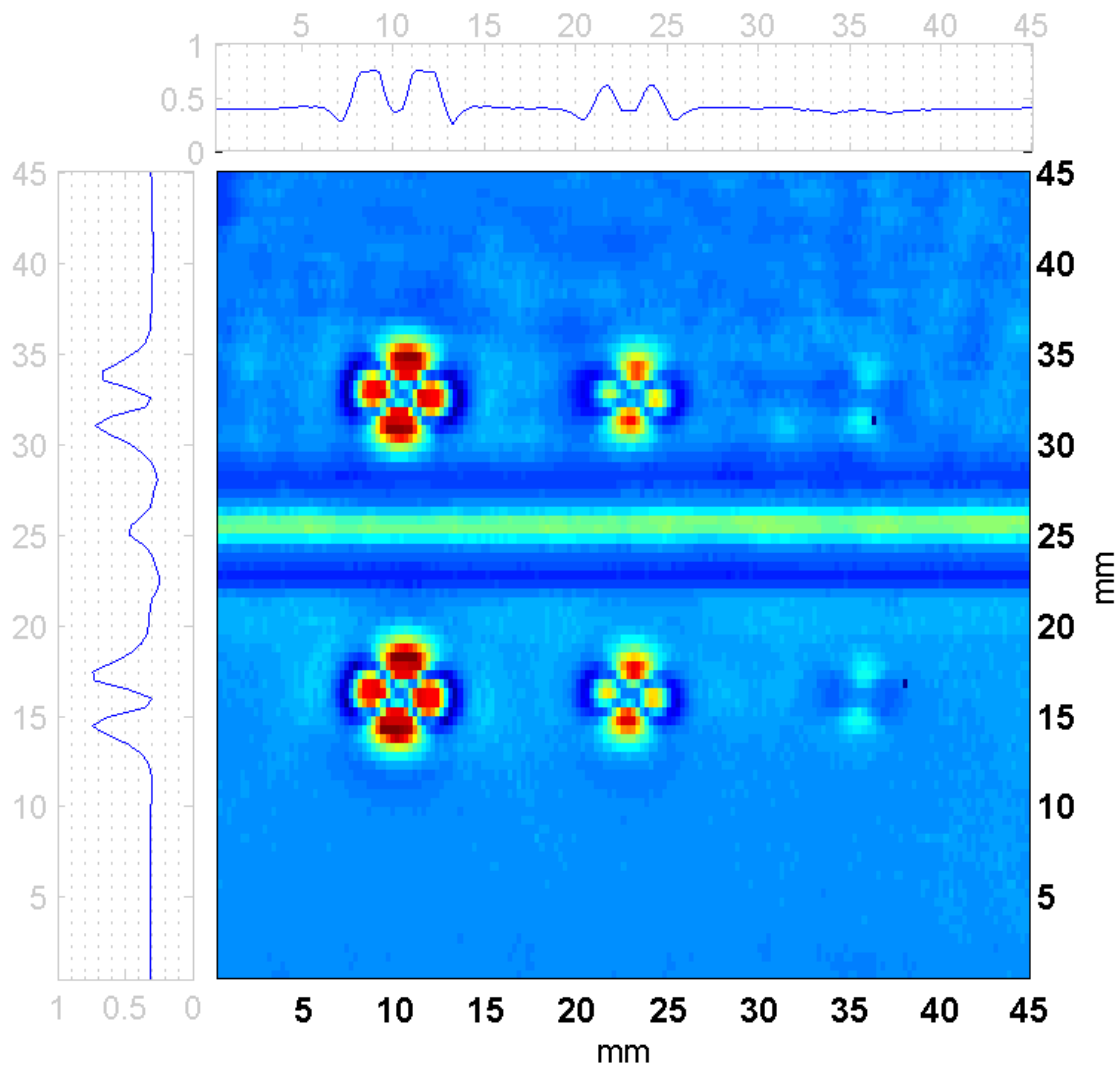
Figure B-2.

Sample:	PB Block
Mitigated Region:	Lower half
Instrument:	ZETEC MIZ 22
Probe:	ZETEC 3479-1-A Plus Point (run in differential mode)
Scan Size:	45 mm × 45 mm
X Step Size:	0.25 mm
Y Step Size:	0.50 mm
Test Frequency:	240 kHz
Gain:	26 dB
V/H:	8/8
Phase:	0 degrees

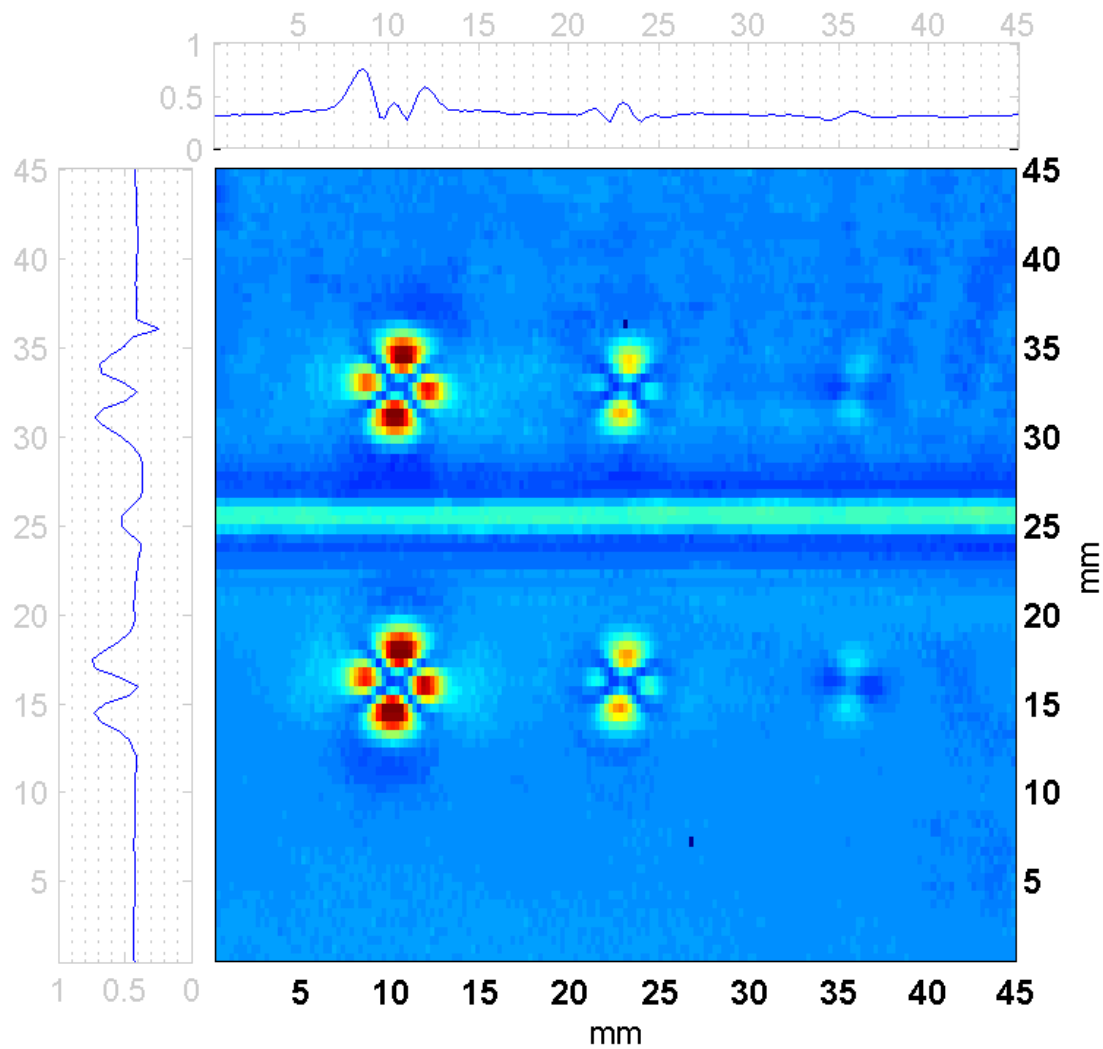
Figure B-3.

Sample:	PB Test Block
Mitigated Region:	Lower half
Instrument:	ZETEC MIZ 22
Probe:	ZETEC 3479-1-A Plus Point (run in differential mode)
Scan Size:	45 mm × 45 mm
X Step Size:	0.25 mm
Y Step Size:	0.50 mm
Test Frequency:	50 kHz
Gain:	36 dB
V/H:	8/8
Phase:	294 degrees

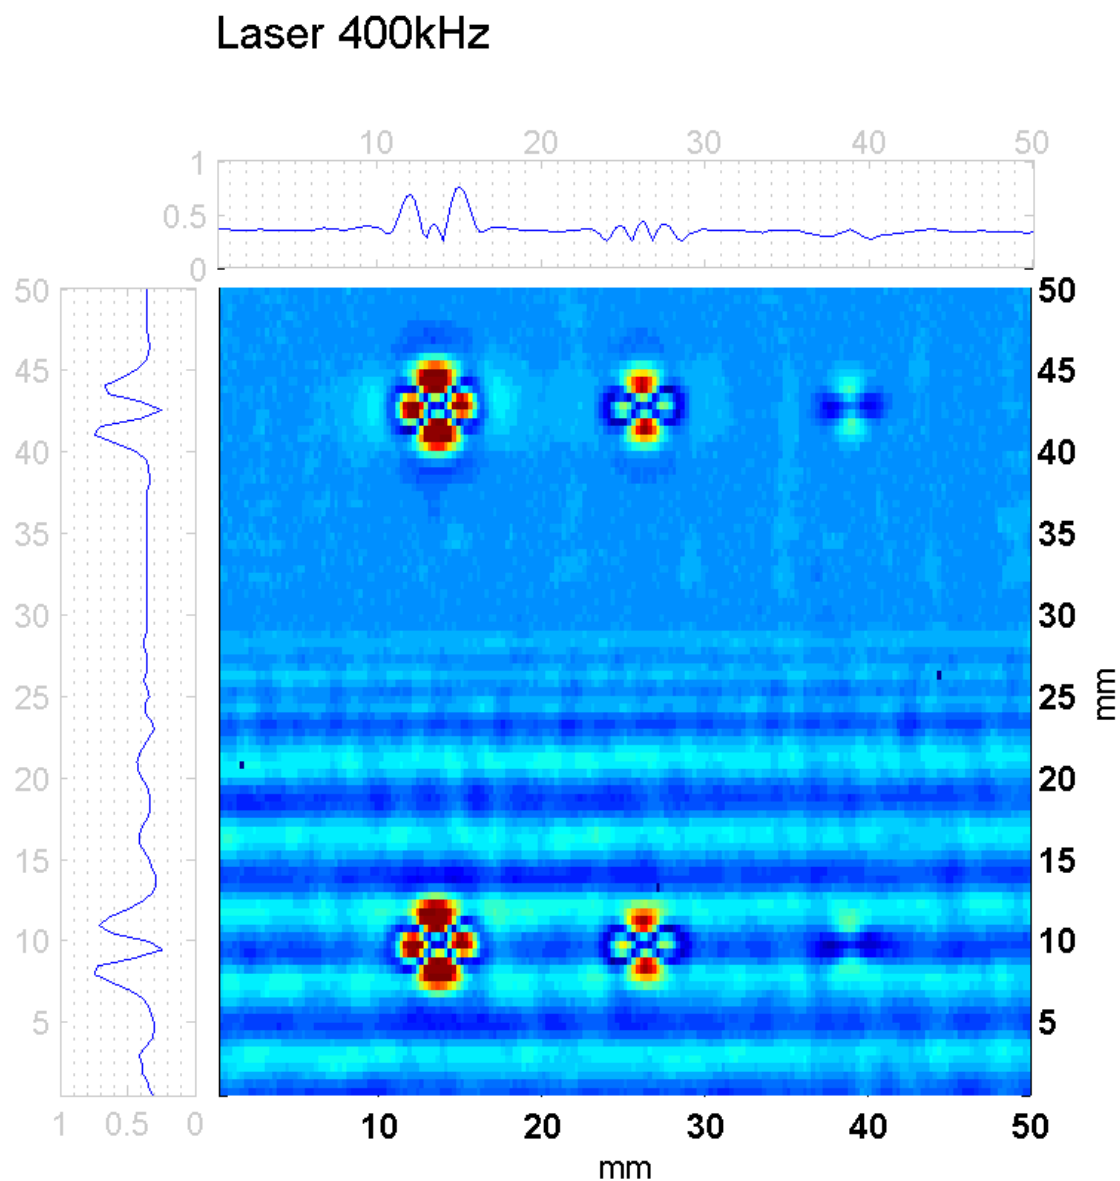
Figure B-4.

Sample:	LP Block
Mitigated Region:	Lower half
Instrument:	ZETEC MIZ 22
Probe:	ZETEC 3479-1-A Plus Point (run in differential mode)
Scan Size:	50 mm × 50 mm
X Step Size:	0.25 mm
Y Step Size:	0.50 mm
Test Frequency:	400 kHz
Gain:	26 dB
V/H:	8/8
Phase:	25 degrees

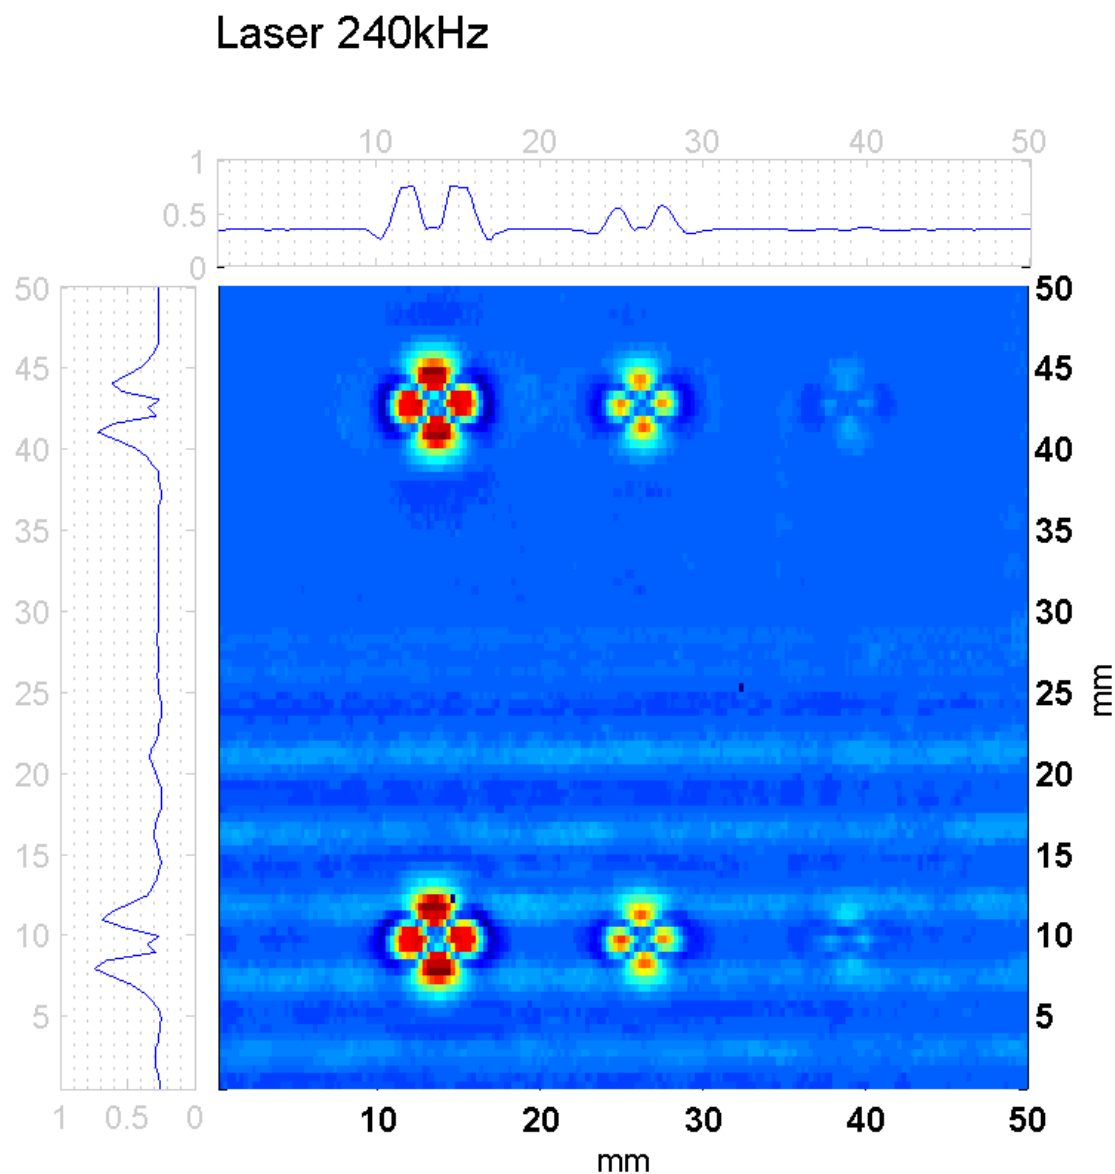
Figure B-5.

Sample:	LP Block
Mitigated Region:	Lower half
Instrument:	ZETEC MIZ 22
Probe:	ZETEC 3479-1-A Plus Point (run in differential mode)
Scan Size:	50 mm × 50 mm
X Step Size:	0.25 mm
Y Step Size:	0.50 mm
Test Frequency:	240 kHz
Gain:	26 dB
V/H:	8/8
Phase:	0 degrees

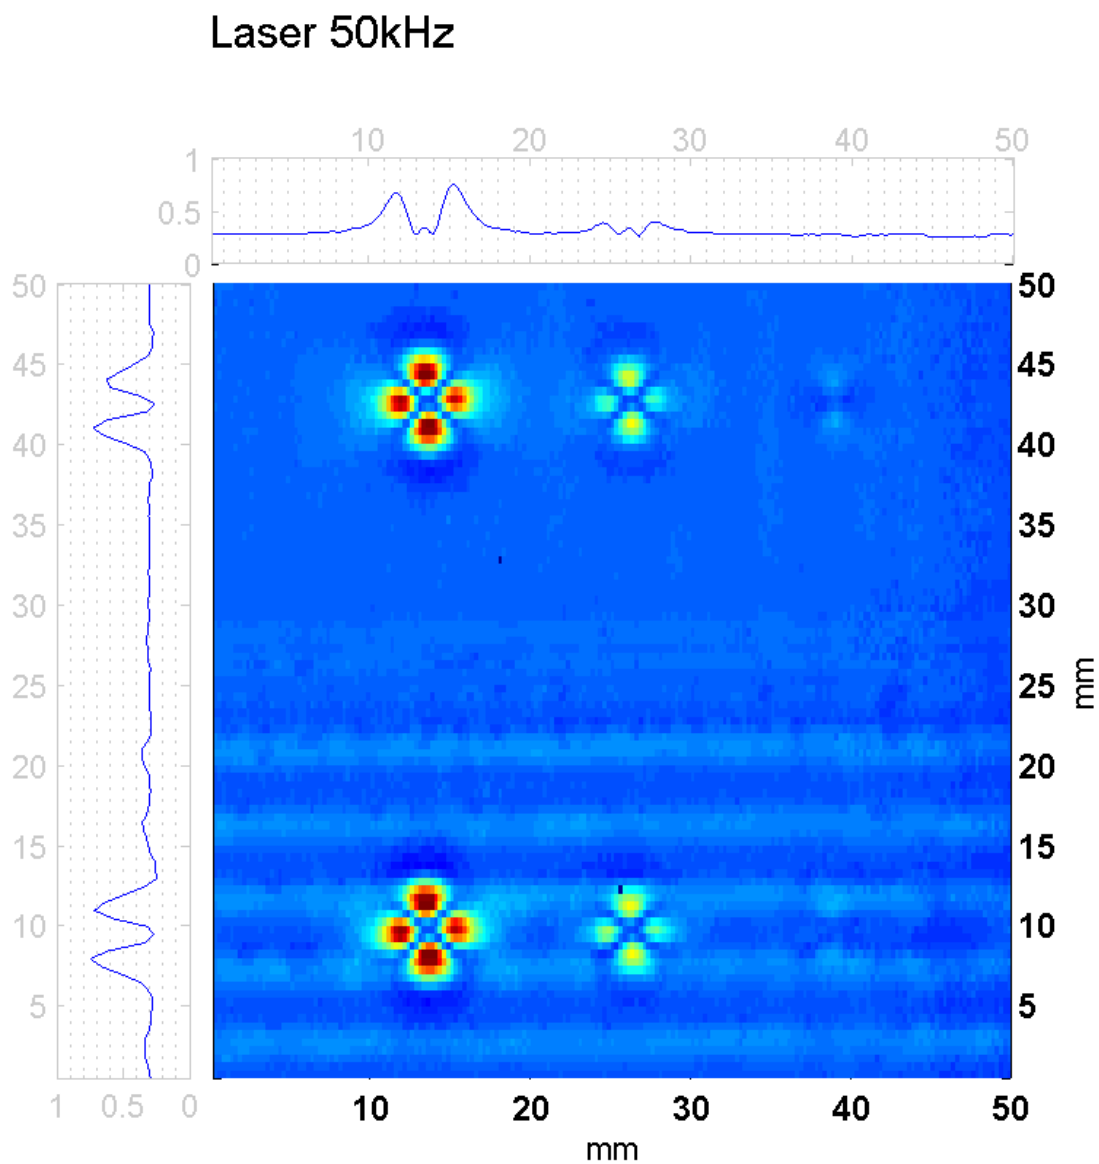
Figure B-6.

Sample:	PB Block
Mitigated Region:	Lower half
Instrument:	ZETEC MIZ 22
Probe:	ZETEC 3479-1-A Plus Point (run in differential mode)
Scan Size:	50 mm × 50 mm
X Step Size:	0.25 mm
Y Step Size:	0.50 mm
Test Frequency:	50 kHz
Gain:	36 dB
V/H:	8/8
Phase:	294 degrees

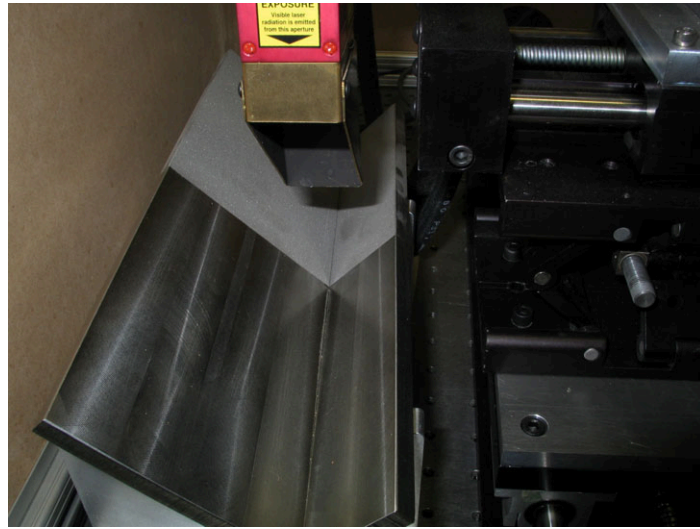
Figure C-1. Setup of a fillet weld to demonstrate the difference between a shiny and dull surface.

Applying a laser-stripe-based sensor to a shiny surface can cause misinterpretation of the profile. Although not an issue with a finish weld joint without an angle approaching 90 degrees, this appendix provides background on the reflective surface observation in the discussion section of this report. Figure C-1 shows the setup of the visual sensor on a fillet weld. Figure C-2 shows the result of the laser stripe on the two surfaces. Because the opposing surfaces reflect the light between each other, a *butterfly* effect is shown in the highly reflective surface. The larger the included angle in such a setup, the less of an effect is present. For the outer lid, the angle essentially becomes 180 degrees and produces none of this effect.

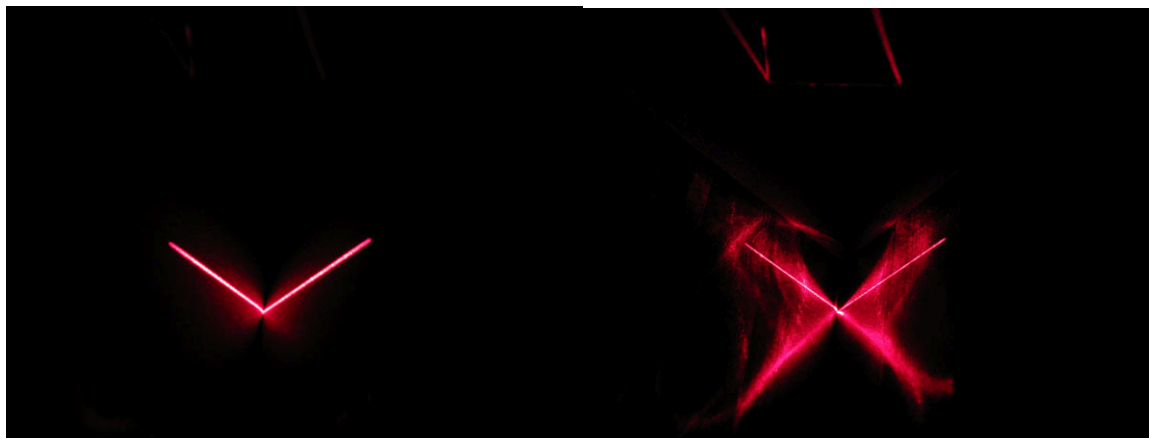
(a) Result from dull surface.

(b) Result from shiny surface.
